Manhole Inspection Summary

Manhole # S39E2_009MH

Insp Date: **1/2/08 9:20 AM**

Location Address: **4124 Hague Ave**

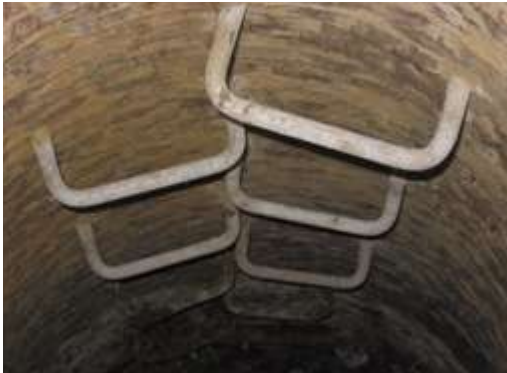
Steps Count: **8** Missing: **0** ☐ Corroded

steps

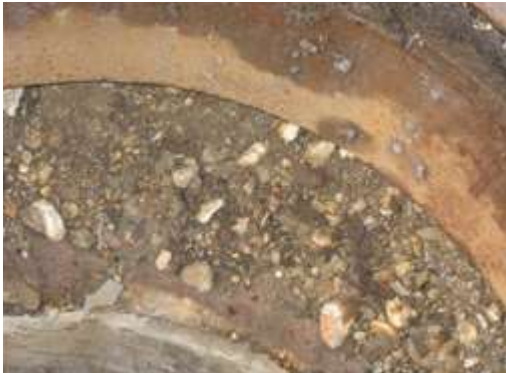
Defect 1

Frame Offset: **3** (in.) Condition: ☒ Sound ☐ Cracked ☐ Leaks

frame offset

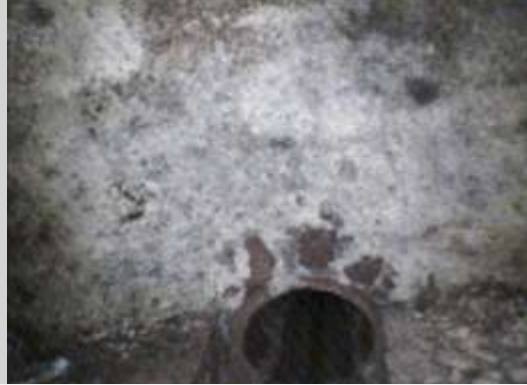
12 O'Clock Outflow

8 in. Circular Gravity Sewer
Pipe Out @ 12 O'Clock

Pipe Height: **9.6** (in.) Rod and Bar (Angled)
Pipe Material: **Clay** ☐ Pipe Lined
Invert Depth: **15.32** (ft.) Flow Characteristics: **Slow**
Deposits: ☒ None ☐ Mud ☐ Sludge ☐ Debris ☐ Grease
Silt Depth: (in.) Deposits Extent:
Infiltration: **None** Pipe Seal Cond: **Sound**

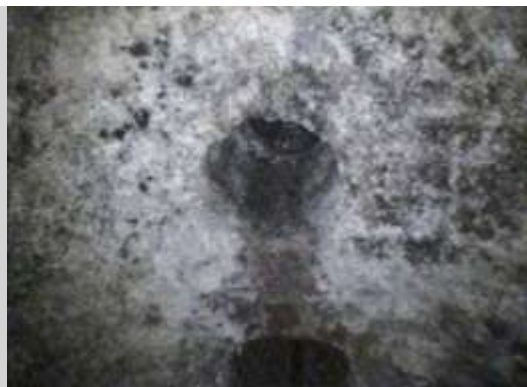
6 O'Clock Inflow

8 in. Circular Service Sewer
Pipe In @ 6 O'Clock

Drop In @ 6 O'Clock

Pipe Height: **9.6** (in.) Rod and Bar (Angled)
Pipe Material: **Clay** ☐ Pipe Lined
Invert Depth: **13.72** (ft.) Flow Characteristics: **Slow**
Deposits: ☒ None ☐ Mud ☐ Sludge ☐ Debris ☐ Grease
Silt Depth: (in.) Deposits Extent:
Infiltration: **None** Pipe Seal Cond: **Sound**

Drop: **Inside** Rod and Bar
Angled: **Yes** Reading: **14.14** (ft.)
Inv Depth: **15.14** (ft.)
Drop Condition: **Open**
